LEVEL 2

Your survey report...

Overall opinion and summary of the condition ratings

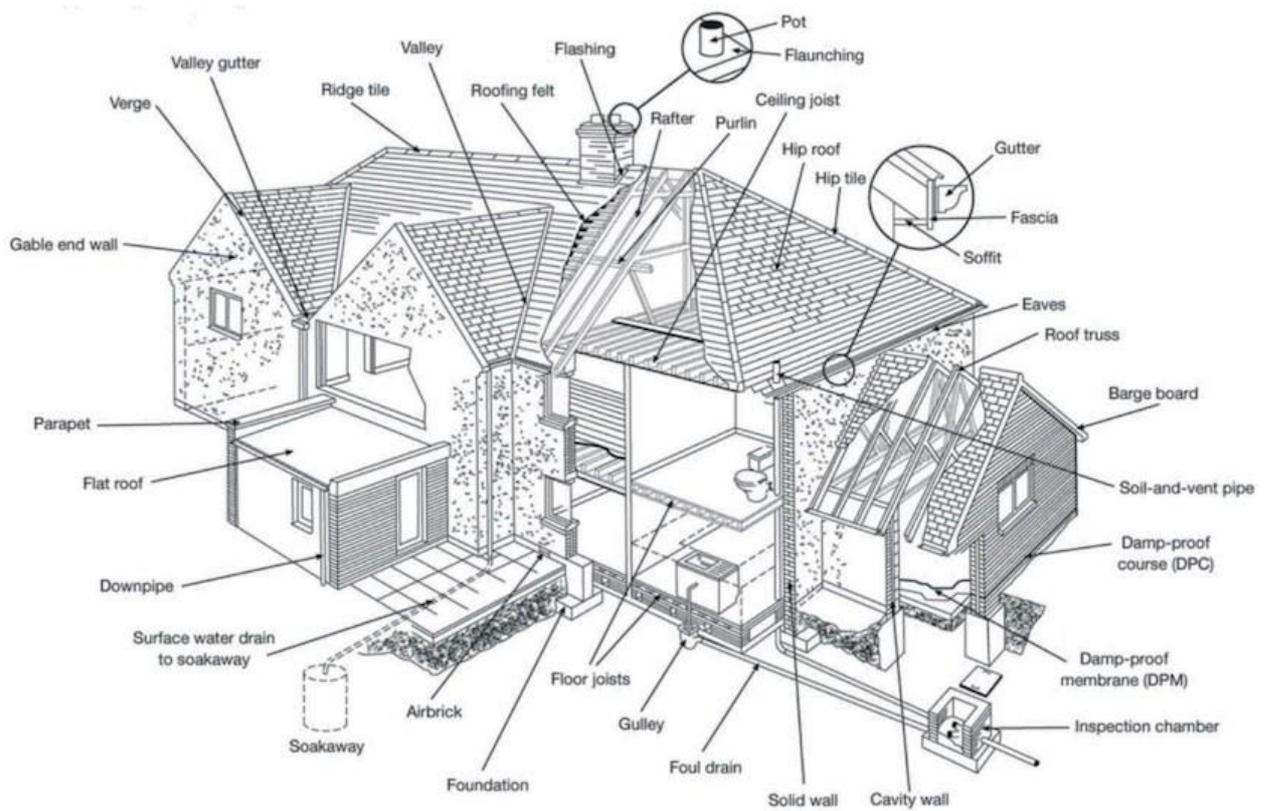
Typical house diagram

This diagram illustrates where you may find some of the building elements referred to in the report.
